## Observations and Analyses of the 9 January 2018 Debris-Flow Disaster, Santa Barbara County, California

**Key Terms:** *Post-Fire, Debris Flows, Alluvial Fan, Narrow Cold Frontal Rain Band, Rainfall Intensity, Inundation, Montecito, Thomas Fire, Loss Estimate*

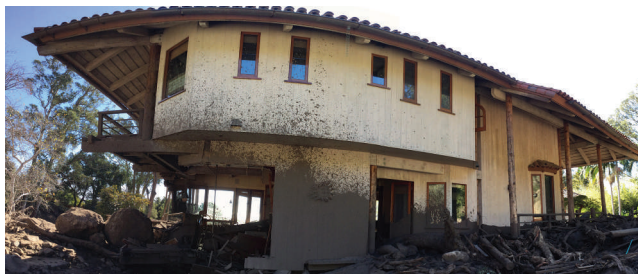
Figure 2. Damaged home along Buena Vista Creek sitting among a debris-flow boulder field and abundant woody debris. Mud line on building is asymmetric, indicating surge-front depths were greater on the left side of the structure (near the top of the handrail on upper floor deck) than on the right side (photo: Brian Swanson, CGS; all photos taken by USGS and CGS unless otherwise noted).

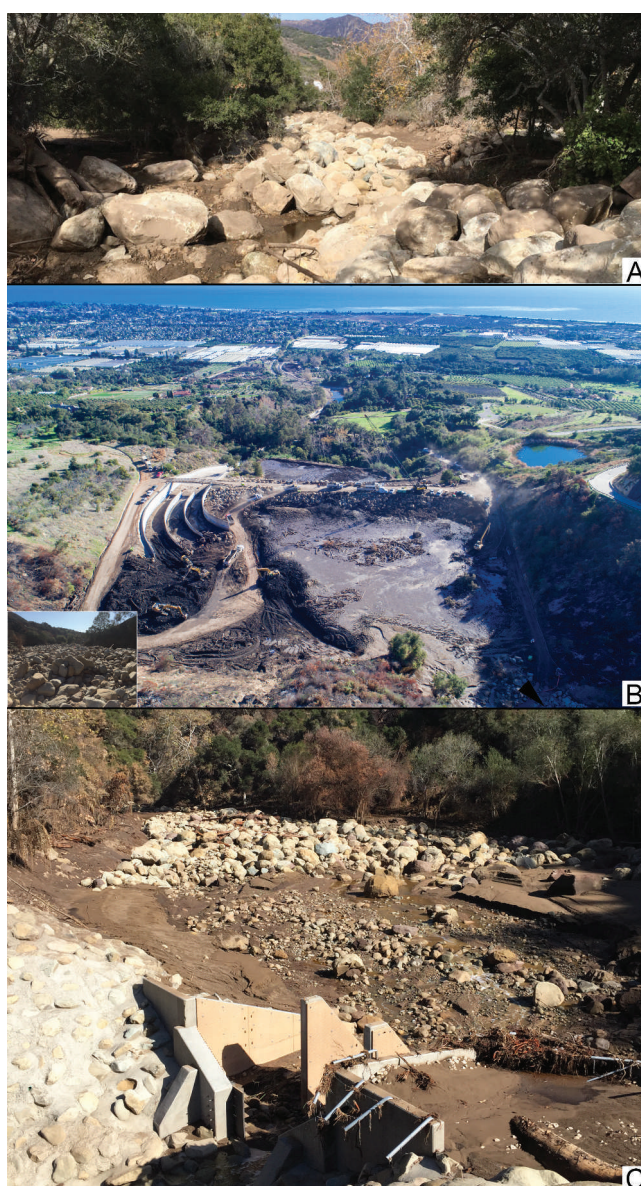
Figure 12. Photo locations from inset rectangles on Figure 5. (A) View north of Arroyo Paredon Creek north of Foothill Road, showing boulder fields from surge-front deposition in previously entrenched channel. Maximum boulder size observed in this general area was 3.9 m. (B) View south of Santa Monica debris basin (SMDB on map) full of fine-grained slurry with piles of raked trees and woody debris around the spillway; massive boulder field located with arrow and shown as inset photo indicates where some of the surge fronts came to rest as flow front lost both confinement and gradient (photo taken by Lael Wageneck, SBCFCD). (C) View north of Gobernador debris basin (GODB on map) with concrete breakers at the outlet, and boulder deposition from debris-flow surge fronts at the upstream junction of the creek and debris basin; largest boulders are 2.5 m in maximum dimension.
